Prosthetic resolution of malpositioned dental implants with 5-year follow-up

In this context, the present study aims to show an alternative resolution for implants that are poorly positioned and deeply installed, in order to minimize damage to osseointegration and gingival tissues.

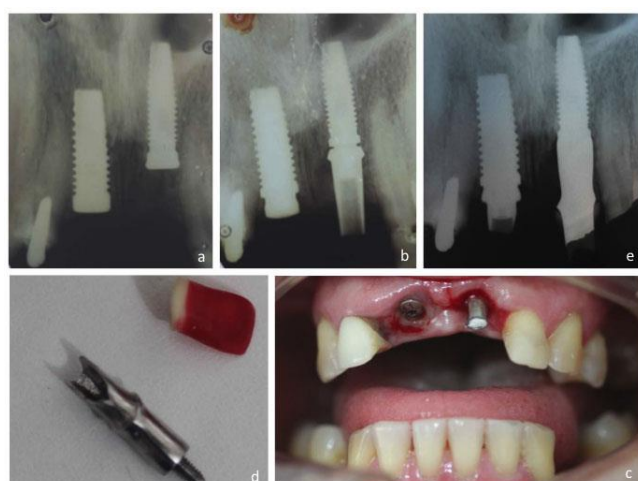
two implants in regions 11 and 21. With the aid of a radiographic examination, it was verified that there were two Revolution External Hex implants (S.I.N. Implant System, Brazil), which presented a diameter of 5.0mm and length of 11mm in element 11 and 4.0mm by 11mm long in element 21 and a height discrepancy of approximately 7mm (Figure 1a). The proposed initial treatment plan was to perform esthetic-functional rehabilitation, since the patient had several dental absences in the buccal cavity, but due to previous trauma the patient chose only to resolve the installed implants, rather than removing them. Thus, two metal-free crowns with zirconia structure were proposed. The greatest difficulty in the case was the selection of the prosthetic component, considering that the implant was installed far below the cervical region of the teeth. Thus, during the reopening procedure a metallic UCLA was used as a healer of 21 (Figure 1b), due to the absence of scar tissue with sufficient height to perform its function (Figure 1c). For the preparation of the prosthesis, a customized abutment was used with its end in the correct region for preservation of periodontal health (Figure 1d and 1e).

Figure 1: Initial radiography (a); Radiography with titanium UCLA in position (b); Intral-oral aspect with titanium UCLA (c); Machined abutment with coping in duralay (d); Radiography with the installed machined abutment (e).

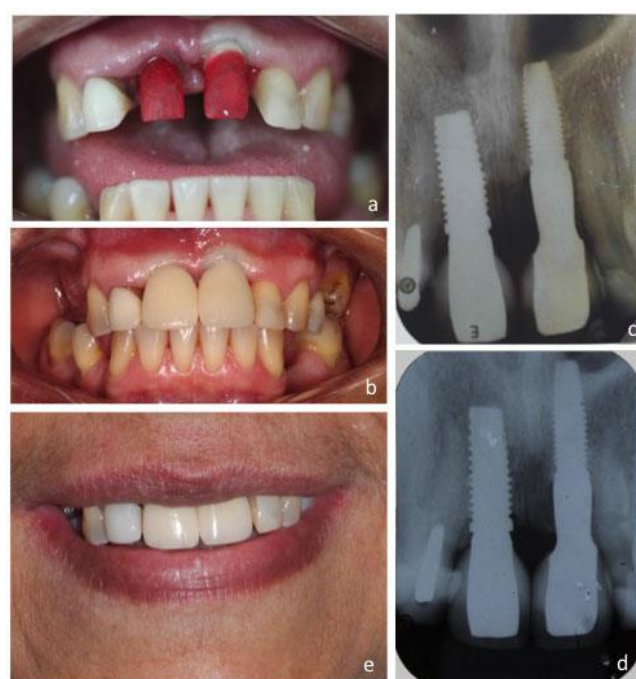
After installation of the prostheses, the patient was satisfied with the esthetic-functional result, leading to the end of the case in an atraumatic way, that is, without the need to remove the implant (Figure 2a, 2b and 2c). After 5 years, the patient returned to the clinic presenting peri-implant bone maintenance and gingival health, with the esthetic-functional result maintained, thus, evidencing that the alternative chosen for this case was successful (Figure 2d and 2e).

Figure 2: Intraoral aspect with coping in duralay (a); Final aspect of the metal-free crowns with zirconia structure (b); Final radiographic aspect (c); Final Radiographic appearance after 5 years (d); Complete smile, 5 years after treatment (e).
